# THE GROWTH OF MULTI-SITE FATIGUE DAMAGE IN FUSELAGE LAP JOINTS

Robert S. Piascik  
NASA Langley Research Center  
Hampton, VA, 23681 USA.  
Tel: (757) 864-3483  
Fax: (757) 864-8911  
E-Mail: r.s.piascik@larc.nasa.gov

Scott. A. Willard  
Lockheed Engineering and Sciences Co.  
Hampton, VA, 23681 USA.

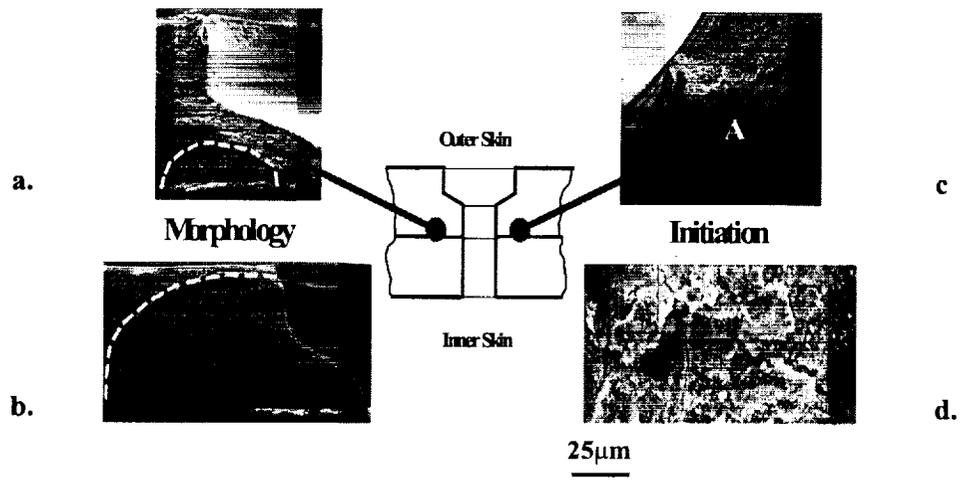
MSD in the fuselage lap joint is a likely result of cracks nucleating from fretting damage and regions of high stress concentration. The majority of fatigue cracks found in the counter bore riveted lap joint initiated along the faying surface (the interface between the outer and inner skins) of the outer skin

shown in Figure 2. Here, clad layer fretting along the faying surface was caused by repeated relative movement of the inner and outer skin in a highly localized contact area around the rivet hole. A black aluminum oxide on the faying surface marked the fretted region that containing debris and microcracks shown in Figures 2c and 2d. From this highly localized damaged region, fatigue cracks grew initially in a near semicircular manner (Figure 2a). As fatigue crack length increased, the crack front became elliptical in shape (Figure 2b). Many outer skin fatigue cracks propagated to a length of nearly two skin thicknesses prior to breaking through the outboard surface of the outer skin. A likely cause for subsurface cracking is lap joint bending loads and/or compressive residual stress produced from rivet head expansion into the counter bore region of the rivet hole. Figure 3 shows a typical region of crack initiation for the straight shank rivet. Figure 3a shows the fretting damage area (region A in Figure 3c) along the inboard surface of the straight shank hole. Figure 3c shows the fatigue crack and rivet hole region at an oblique angle. The micrograph shown in Figure 3b reveals an abraded surface containing microcracks similar to that observed in Figure 2d. Examination of the rivet shank mating surface (directly opposite of the abraded hole surface) revealed a black aluminum oxide region characteristic of fretting. The elliptical crack front shape shown in Figure 3d suggests the presence of lap joint bending loads (similar to that observed for the counter bore rivet (Figure 2)). The three examples shown in Figure 4a are typical examples of cracking observed in the 100°-countersink lap joint. Inboard corner cracks and shank/countersink corner cracks are located in regions of high stress concentration. These regions also exhibited some evidence of rivet/hole contact suggesting that fretting may have contributed to crack initiation. The third small fatigue crack shown in Figure 4a is located along the rivet hole surface in the rivet shank region; here, fretting is a likely cause for crack initiation. The dashed lines in Figures 4a and 4b mark the crack fronts and show that the small cracks in Figure 4a are circular in shape and at longer crack lengths, shown in Figure 4b, the crack front is somewhat circular in shape.

Figure 2. Counterbore rivet outer skin cracking: a) and b) SEM micrographs showing the progression of fatigue cracks (dashed lines mark the crack front), c) micrograph shows the rivet hole at an oblique angle and the location of fretting damage (region A) along the faying surface (site of crack initiation), and d) high magnification micrograph showing fretting debris and microcracks in “ region A of Figure 2c”.

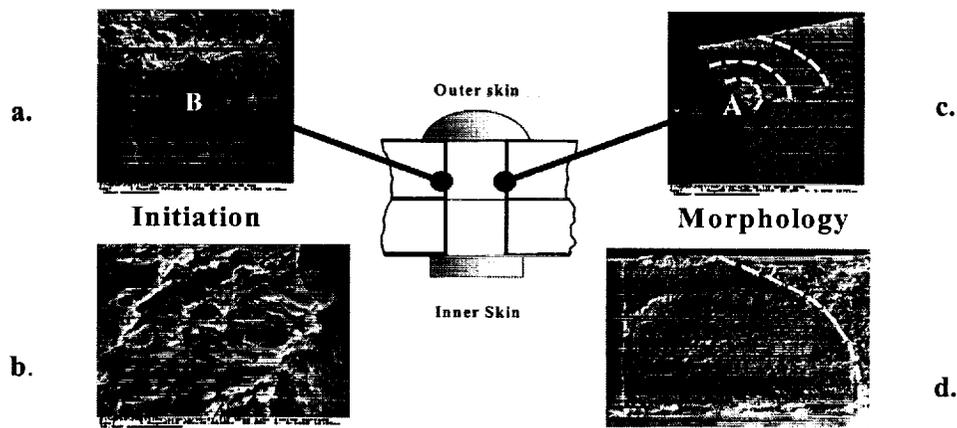
Figure 3. Straight shank rivet outer skin cracking: a) Micrograph of the crack initiation site (region A in “c”), b) high magnification micrograph of fretting surface at region B, c) the micrograph shows the region of crack initiation (region A) along the inside surface of the rivet hole near the inboard corner (dashed lines depict the progression of the fatigue crack), and d) micrograph showing a fatigue crack with multiple initiation sites (arrows) along the surface of the rivet hole (dashed line marks the crack front).

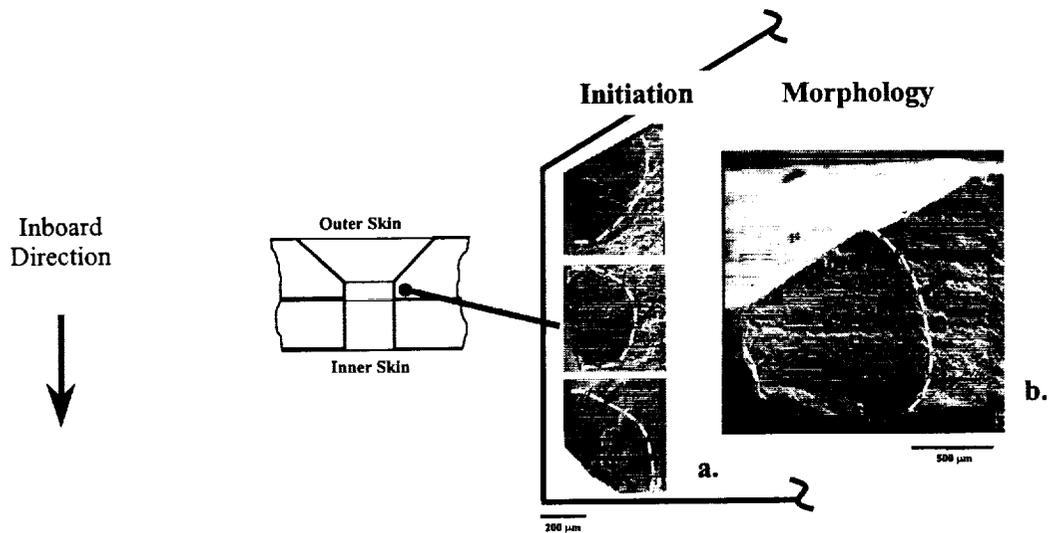
Figure 4. 100° countersink rivet outer skin fatigue cracking: a) Depicted is the outline of the rivet hole and the micrographs show the typical crack initiation sites along the rivet hole surface and crack morphology (dashed lines mark the crack front) and b) shows the typical crack front shape of a fatigue crack that has propagated nearly one-half the length of the counter sink.

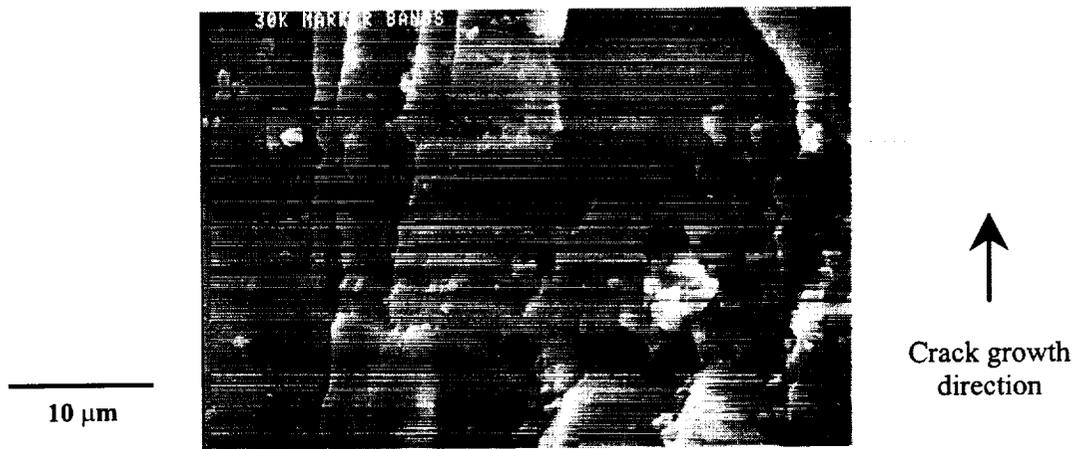
Figure 5 The micrograph shows a markerband from a fatigue crack surface in panel 1. This markerband locates the crack front at 30,000 pressure cycles.
